The Radioactive Material Leak Accident at the Hadron Experimental Facility of J-PARC

June 21, 2013

First External Expert Panel

J-PARC Center
Naohito Saito

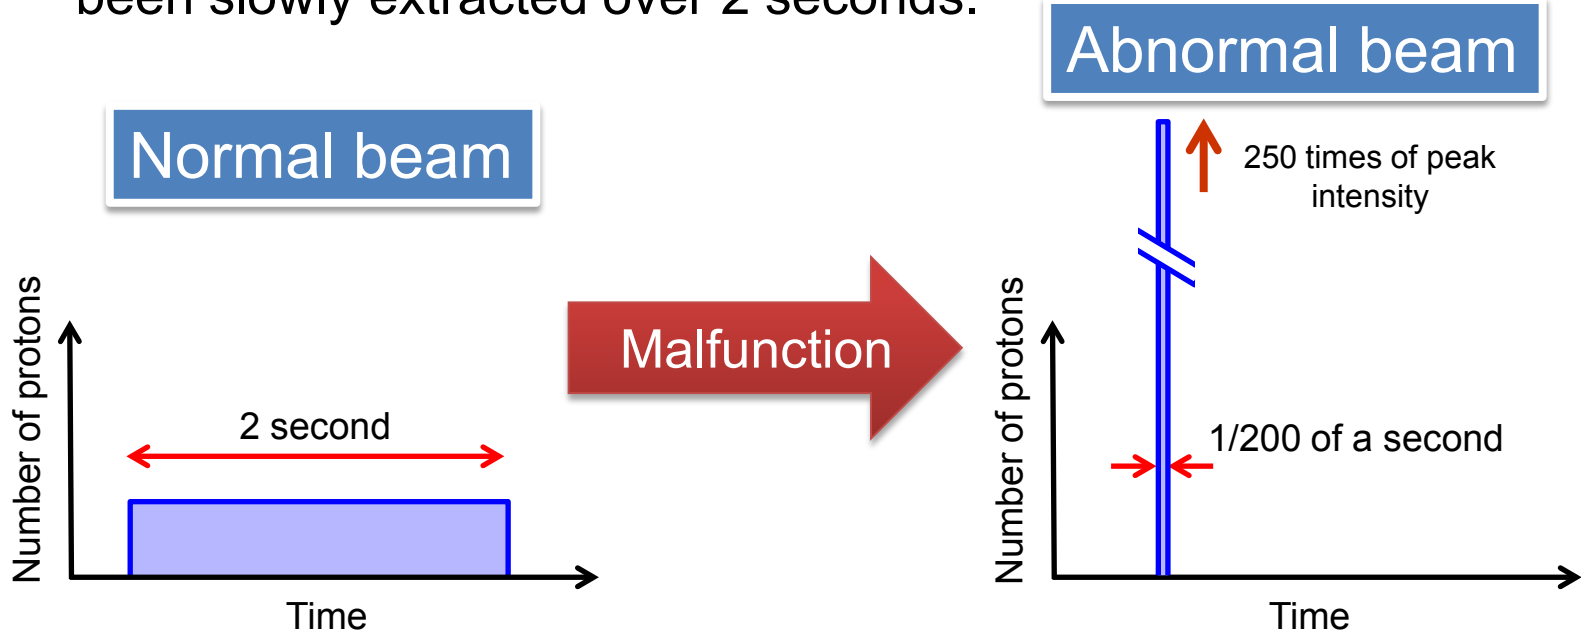
Abnormal Beam

- At around 11:55 on May 23, the power supply system of a special magnet in the 50 GeV Synchrotron malfunctioned.
 - 2×10^{13} protons were extracted in a very short period of 5 milliseconds, while in normal operation 3×10^{13} protons should have been slowly extracted over 2 seconds.

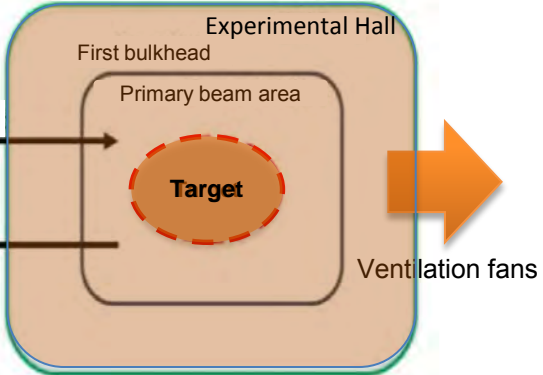
Present status

Apertural areas for secondary beam transport lines

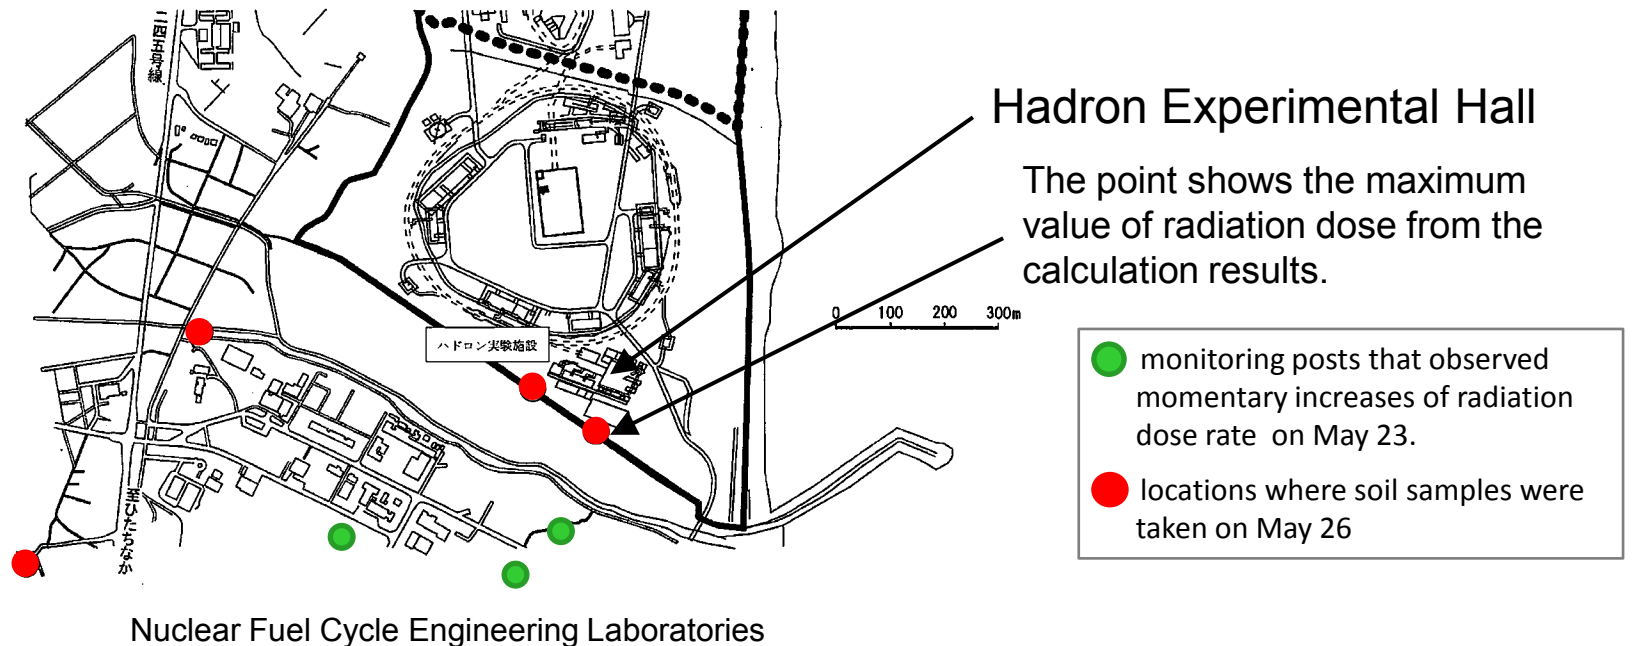
- The released radioactive material distributed within a narrow area of the west from the HD hall.
- The maximum integrated radiation dose at the site boundary is estimated to be $0.29 \mu\text{Sv}$ at a location close to the HD hall.

- Examination of soil samples from four locations.
 - No radioactive material originating from the accident was detected at any of these locations.
