# Report from the Working Group

Working Group for the External Expert Panel on the Radioactive Material Leak Accident at the Hadron Experimental Facility of J-PARC

## Planning of safety measures (Countermeasures against recurrence of similar accidents)

The 3<sup>rd</sup> External Expert Panel Meeting to Review the Radioactive Material Leak Accident at the Hadron Experimental Facility of J-PARC at KKR Hotel Tokyo on 20 June 2013

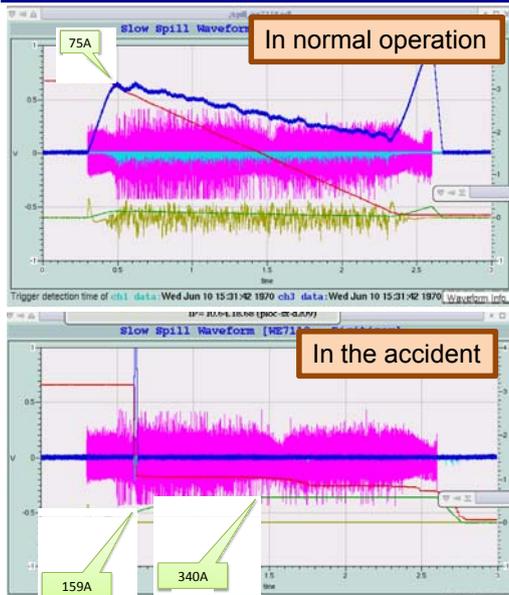
## Stage1: Preventive measures against recurrence of the malfunction of the EQ (extraction quadrupole) system

The power supply for magnets, which control the slow beam extraction, did not properly respond to the command signal in the designated period of beam spill, and then it abruptly brought a large current to the magnets.

- It returned no response to the command signal for the first ~0.3 seconds of the intended beam extraction .
- While the response was restored in 0.3 seconds, the power supply control unit acted as if it was responding to an abrupt step command of 159 A. This set off alarms of an overvoltage condition and a tracking error.
- The investigation confirmed later that the power supply would behave in the way as it did in the accident, when a step command of 159 A is given.
- The reason for the lack of response in the first 0.3 seconds is still under investigation.

Subject	Present	Future
Tracking error of magnet supply current	Display of the error status in the control system window.	Immediate shutoff of the power supply. Halting of continuous beam operation
Maximum current allowed on the EQ power supply	340 A	120 A
Response time to an emergency stop signal of the power supply	> 6 ms	< 1 ms

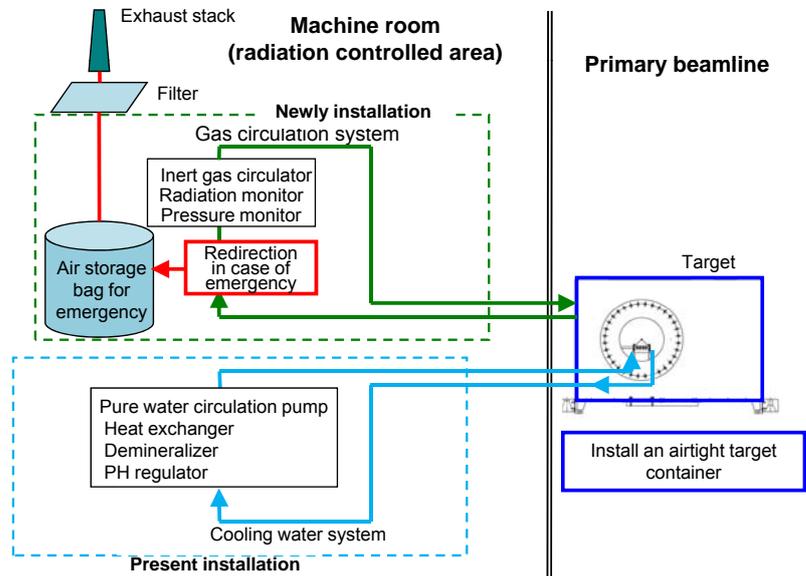
**Schematic of the new target system**

- The beam with a diameter of ~1mm deposited a large amount of energy when it penetrated through the target over a short period of 5 ms, locally heating up the gold target to a very high temperature.
- The gold target was not enclosed in a hermetic container.

- An airtight target container.
- Fill the target container with an inert gas whose flow is controlled by a circulation system.
- Monitor the gas pressure and the concentration of radioactive material within the gas.
- Shorten the time interval of measurement of the target temperature and optimize the alarm threshold.
- Monitor the yield of secondary particles
- Take the target off the beam during accelerator studies.
- Improve the monitors and stop beam operation when an abnormal signal is detected.

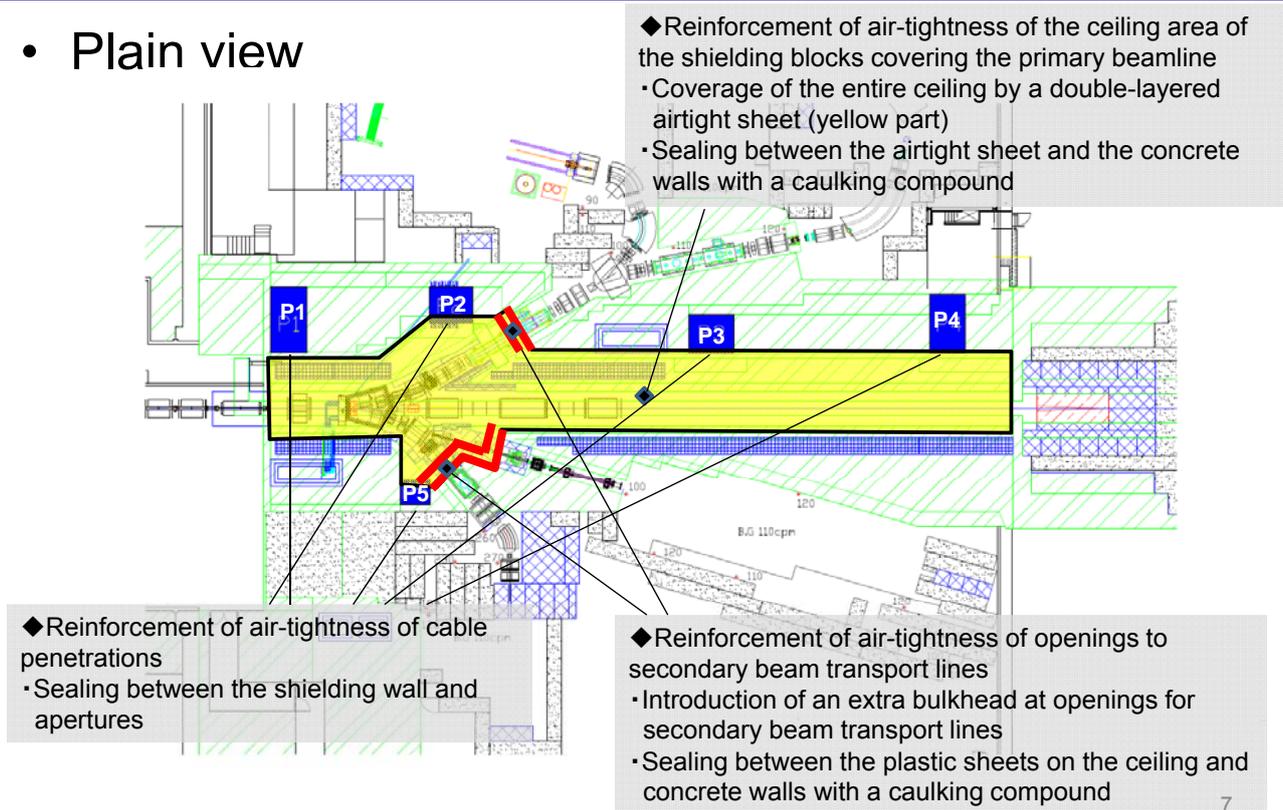
# For stage4: Reinforcement of air-tightness of the primary beamline

- Air-tightness of the radiation shielding wall was insufficient for containing the radioactive material released in this accident.

- Reinforcement of the air-tightness of radiation shields for the primary beamline
  - ✓ Cover widely two shielding-block layers of a ceiling of the primary-beamline with an airtight sheet
  - ✓ Introduction of an extra bulkhead at openings for secondary beam transport lines
  - ✓ Reinforcement of air-tightness of cable penetrations
- Install a radioactivity monitor for the air in the primary beamline area
  - ✓ Stop the beam operation when abnormal signatures are detected.

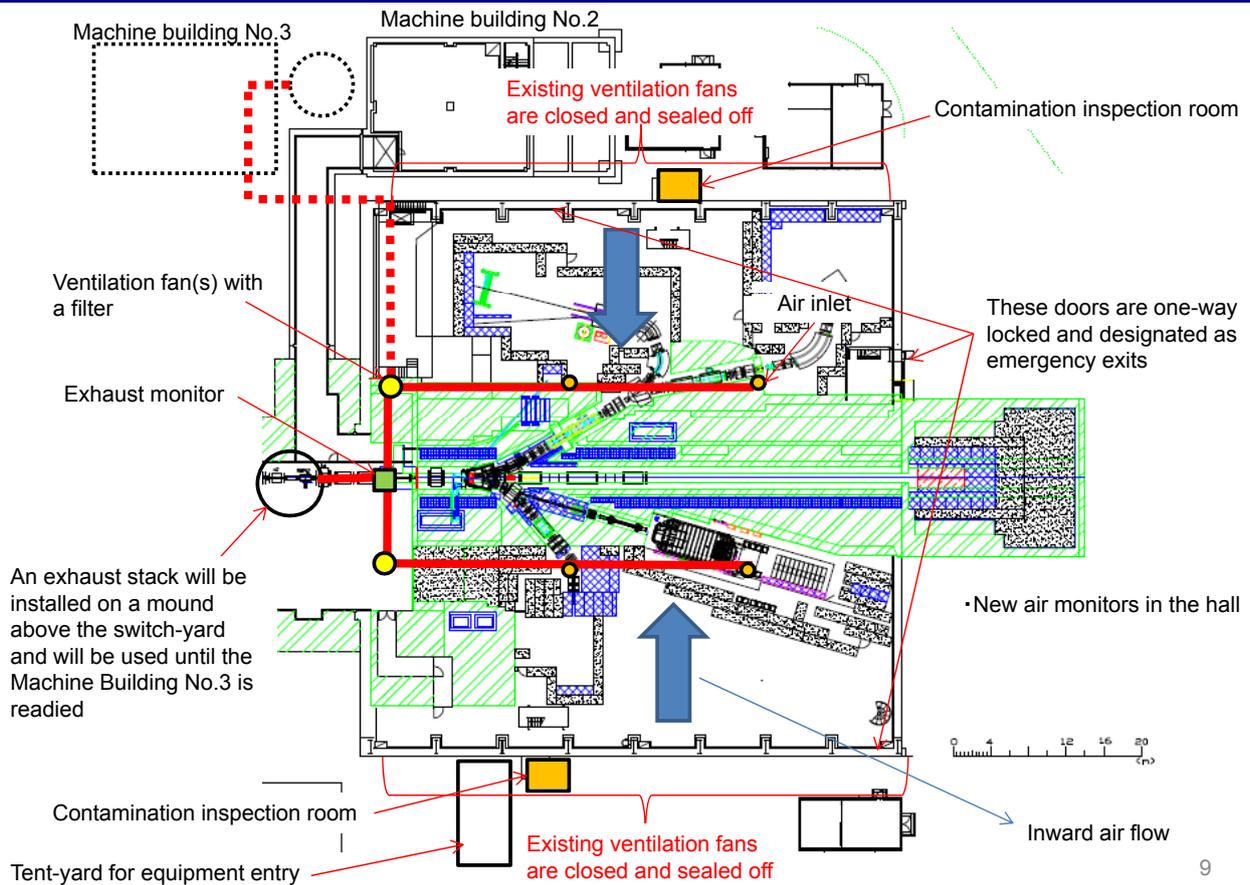
# For stage 5: Improvement of the Hadron experimental hall

The leakage resulted from operations of ventilation fans

- Existing ventilation fans are to be closed and sealed off.
- Air ventilation from the hall will be done through an exhaust stack after filtering while monitoring the radiation level.
- Radiation monitors in the hall will be part of the protection system which stops beam operation when an abnormal radiation level is detected. (It is important to separate false alarms caused, for instance, by a radon isotope.)

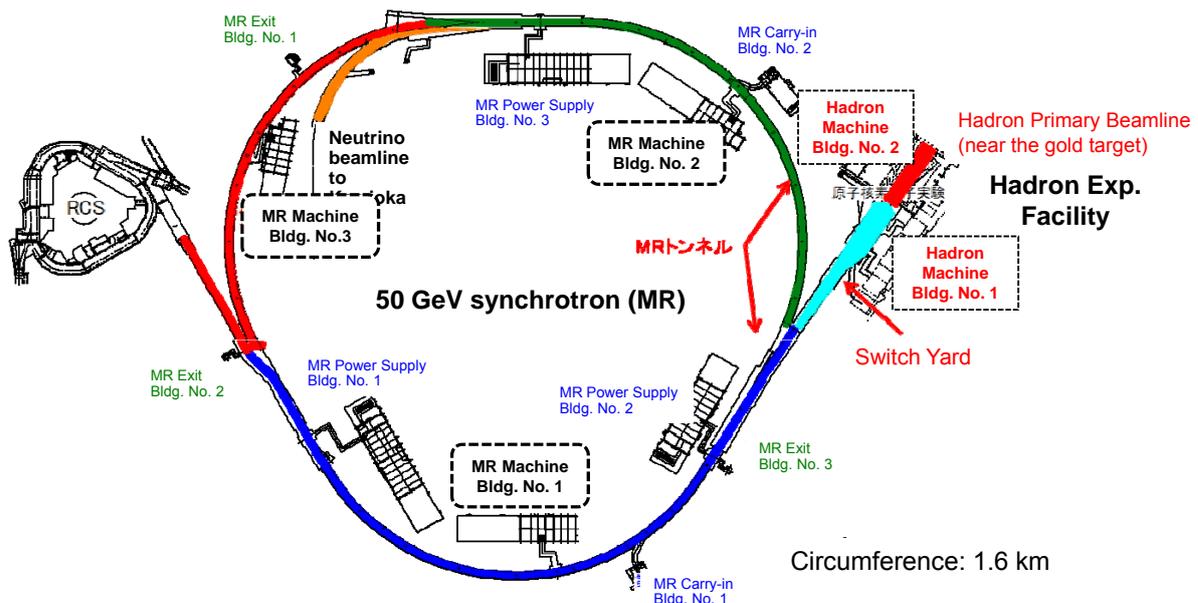
## Layout of machine buildings

Prior to investigation of the gold target, we have to reduce the concentration of radioactive material in the air to prevent spreading of the contamination. For this purpose the air in the tunnel was circulated through charcoal filters while the concentration was monitored.

- On July 11, 2013, HEPA filters were replaced by charcoal filters at the Hadron Machine Bldg. No. 1.
- On July 14, 2013, HEPA filters of other machine buildings were replaced by charcoal filters.
