4 Month Summary after the Earthquake

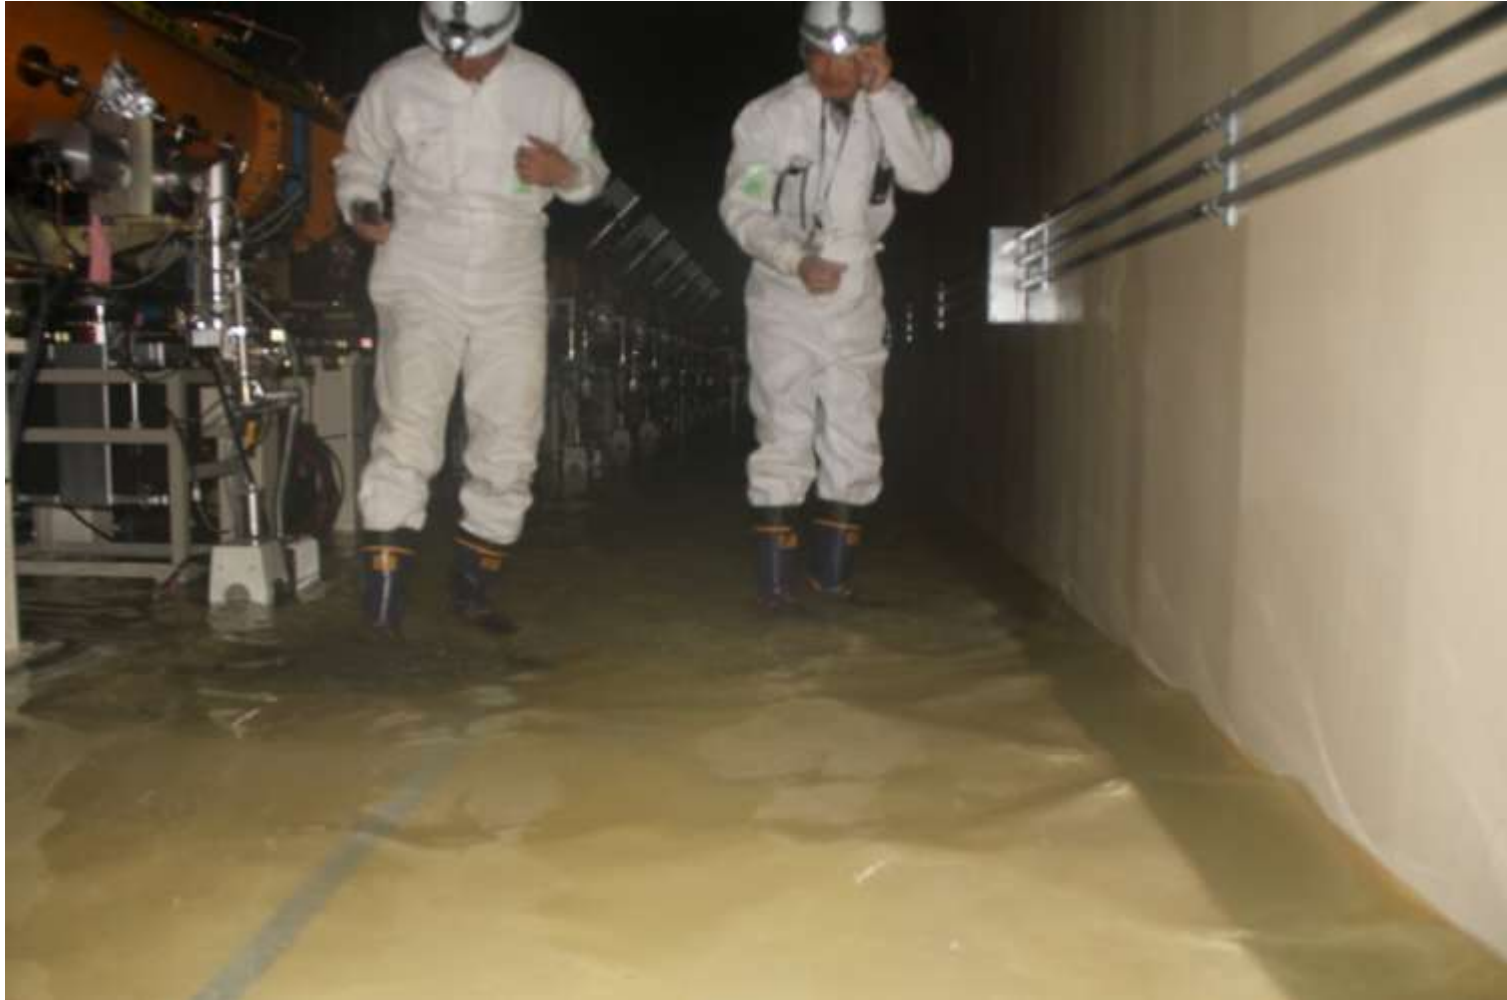
Linac Tunnel as of March 24

On March 17 the water level was only 1 cm, but it increased to 10 cm (100 tons) on March 24. The water was pumped out with an in-house electric generator, and the problems were resolved afterwards.

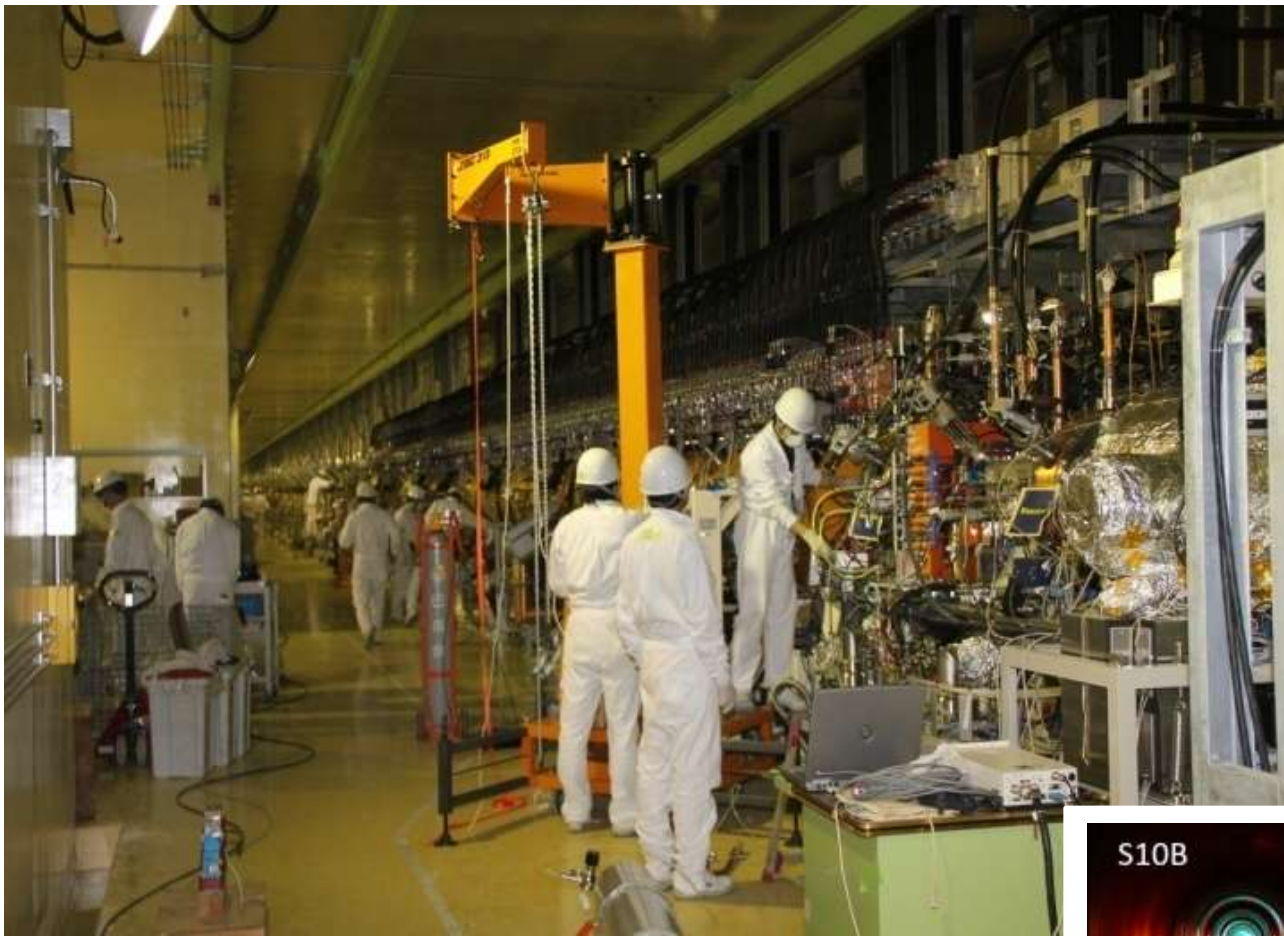
Floor sagged ~4 cm in the middle. However, other places, except beam monitors, were normal. (Beam was aligned step by step through repetition of dropping the beam power and being bent by magnets. A perfect alignment is planned in the next year.)

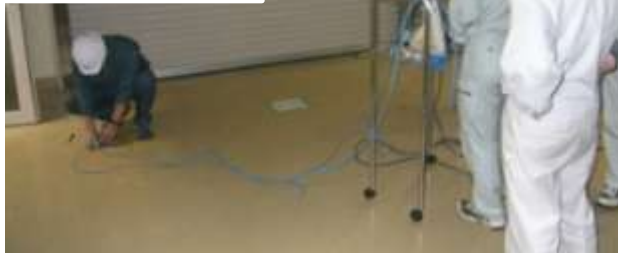
Close inspection of substruction of building with impact elastic wave method and taking cores

~80 cm void was found. The repair plan is discussed. Floor leveling is also investigated.

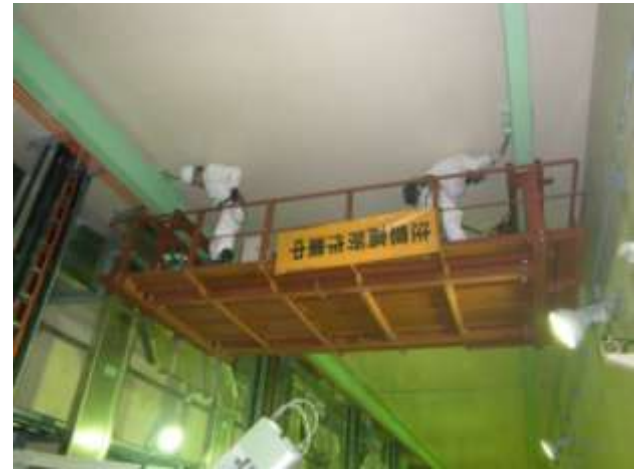
Inspection of crane in the tunnel

Confirming it can be operated with a weight limit.

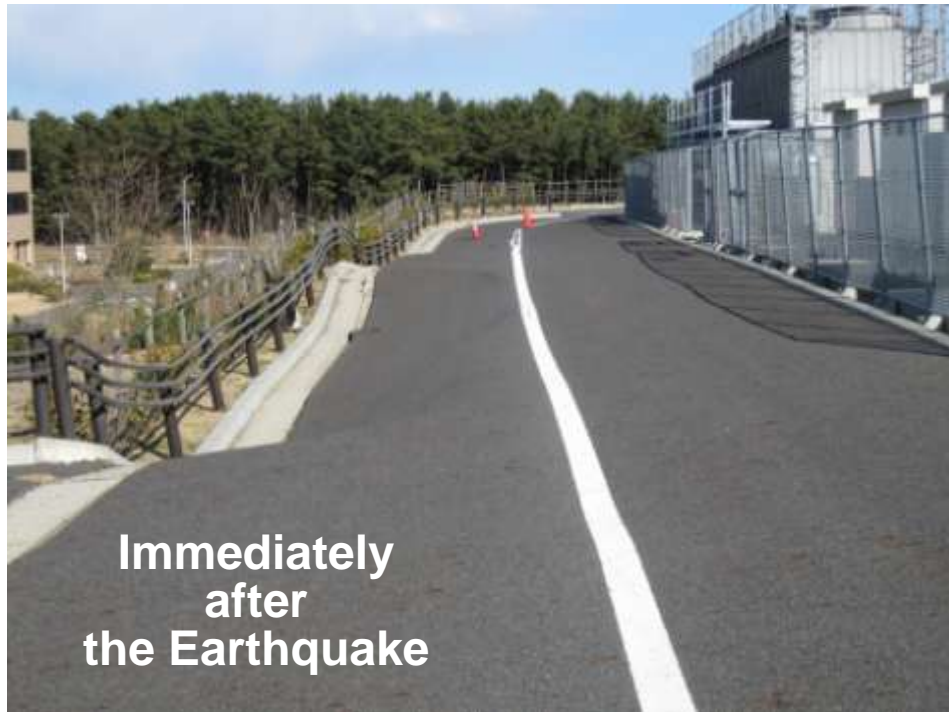
Wavy road!

The side of the road got sagged. The center part remained because the RCS accelerator tunnel for the beam-line was present underneath.

The road was repaved by the end of June. It provides an access to the cooling tower beyond this point. Repair of the electric power supply facility near here has been also kicked-off.

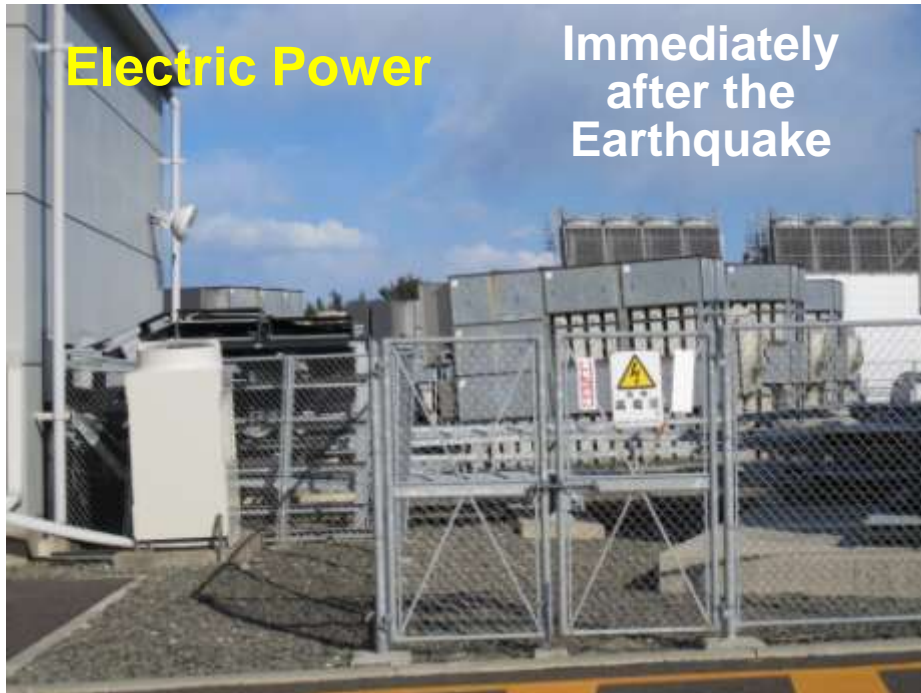
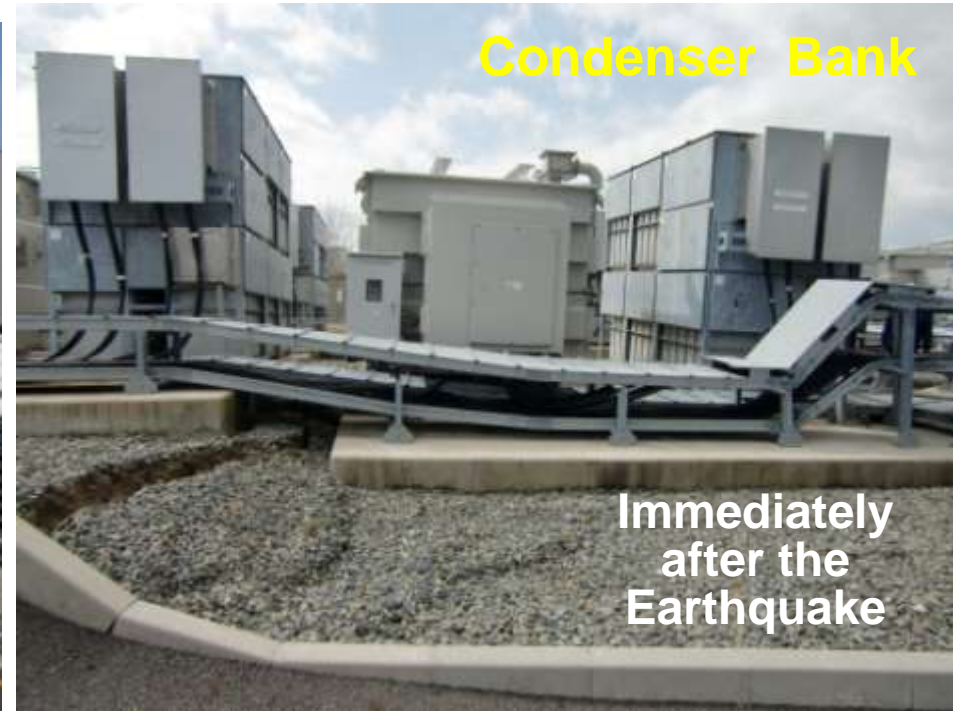
Leaned to the left.

Around the building entrance, approximately 100 cables had been buried, and all of them were distorted.

A condenser (capacitor) bank was tilted. Cables were distorted due to its weight.

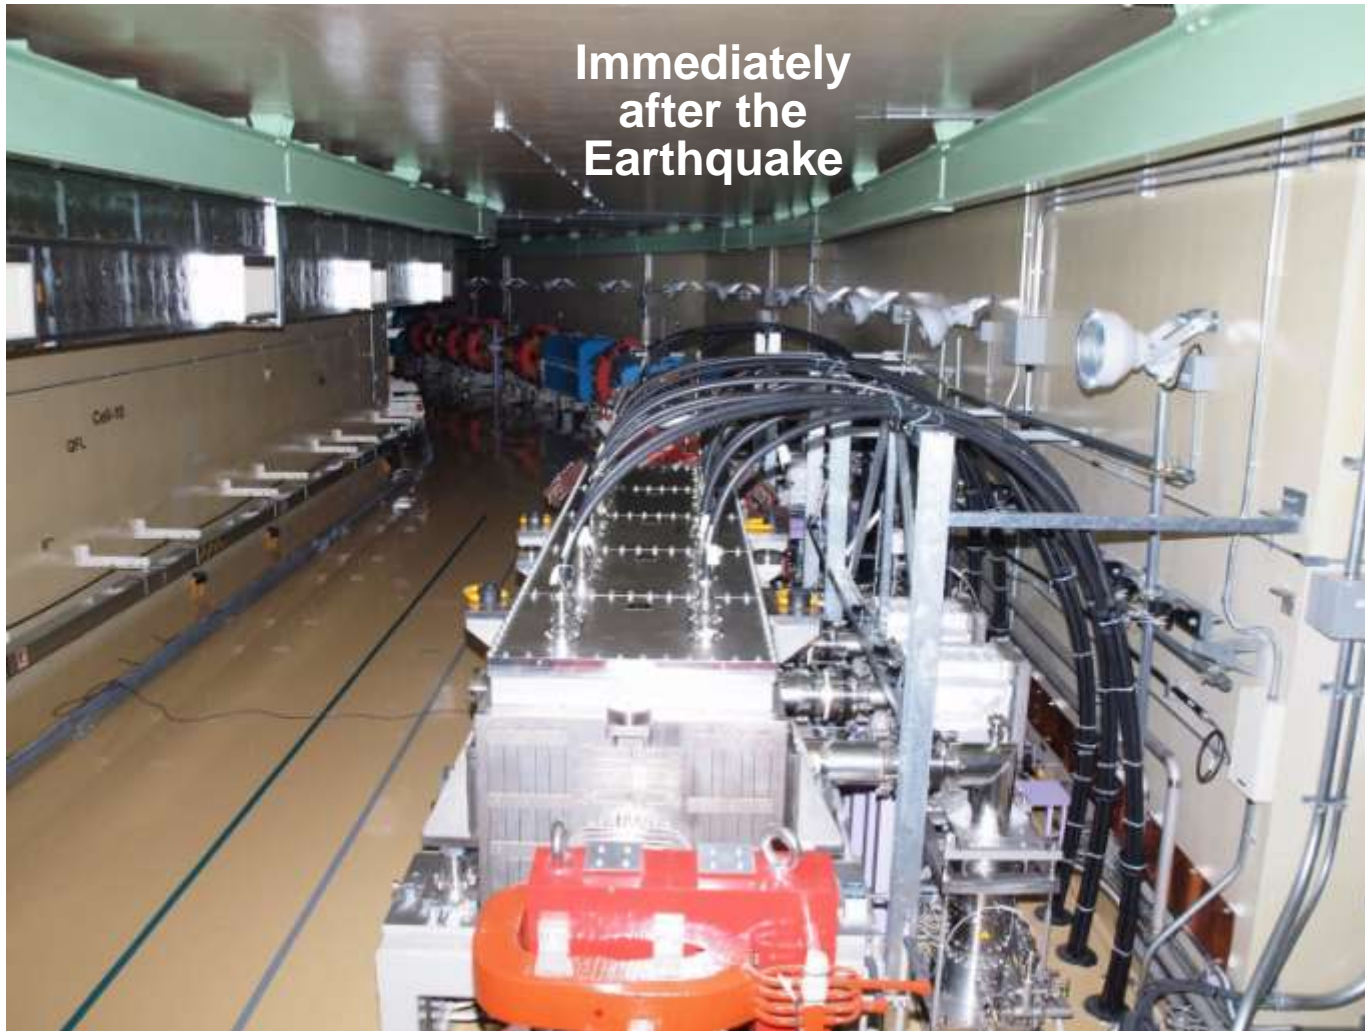
3 GeV Main Ring

No obvious damages were observed.
(Photo taken on March 29)

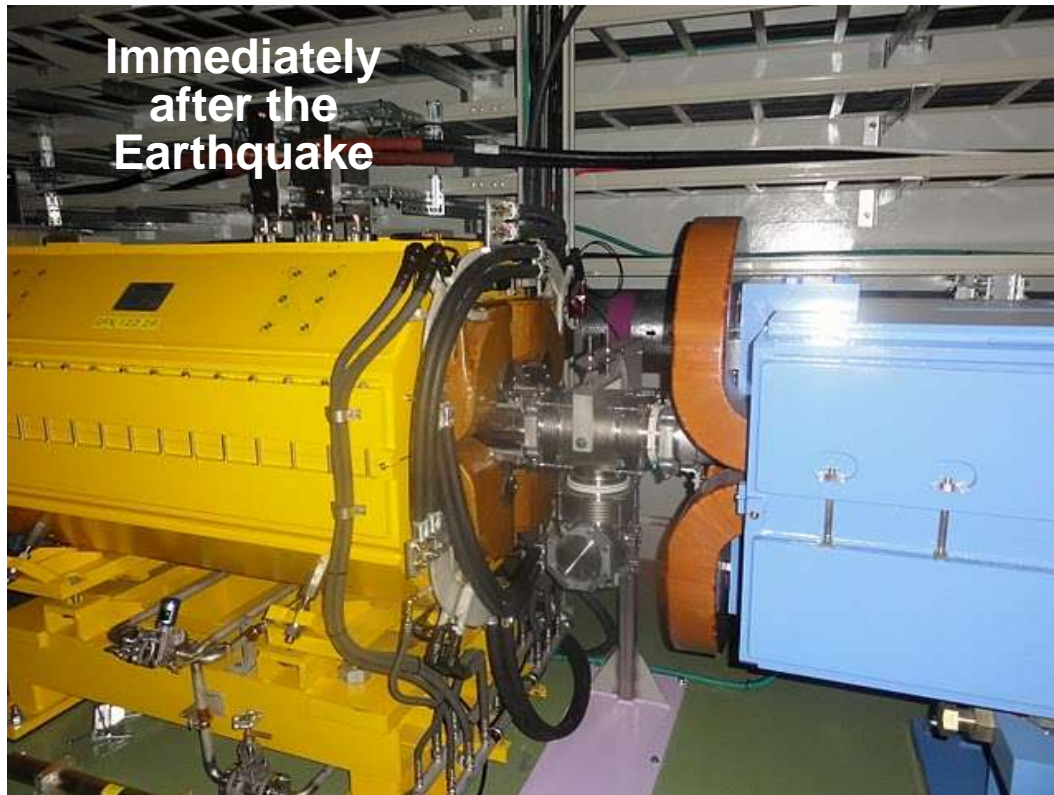
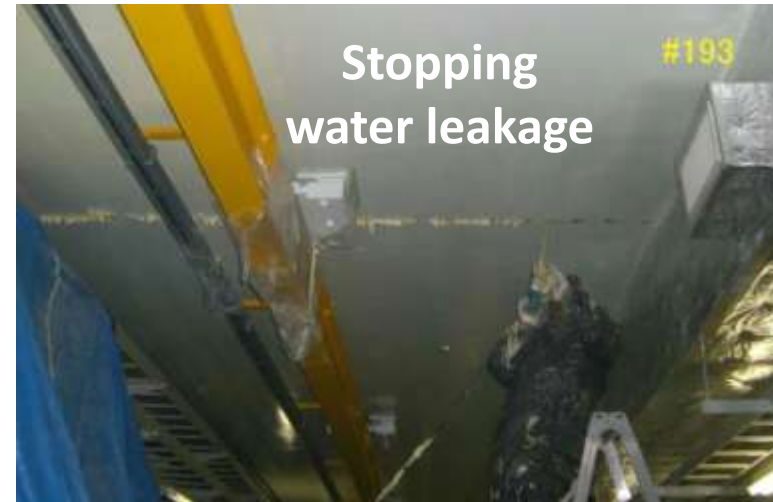
50 GeV Main Ring

No damages were observed through an inspection from the outside alone.
(Photo taken on March 17)

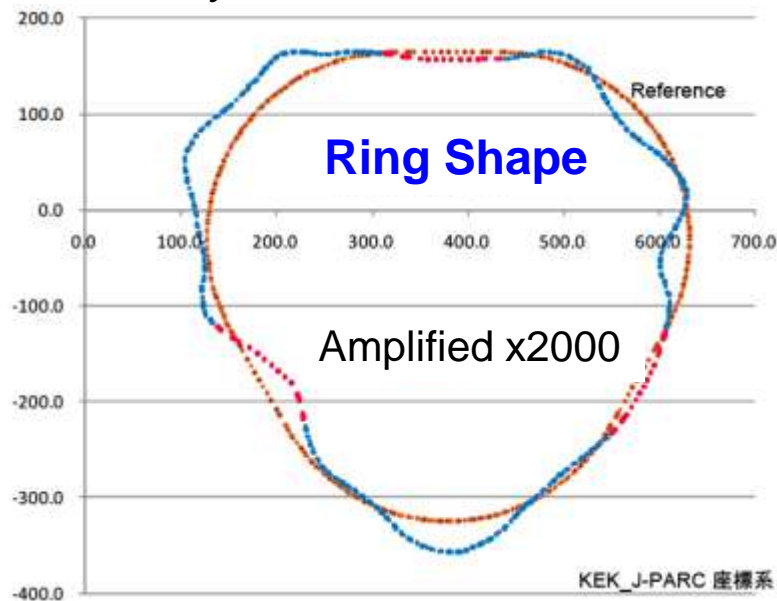
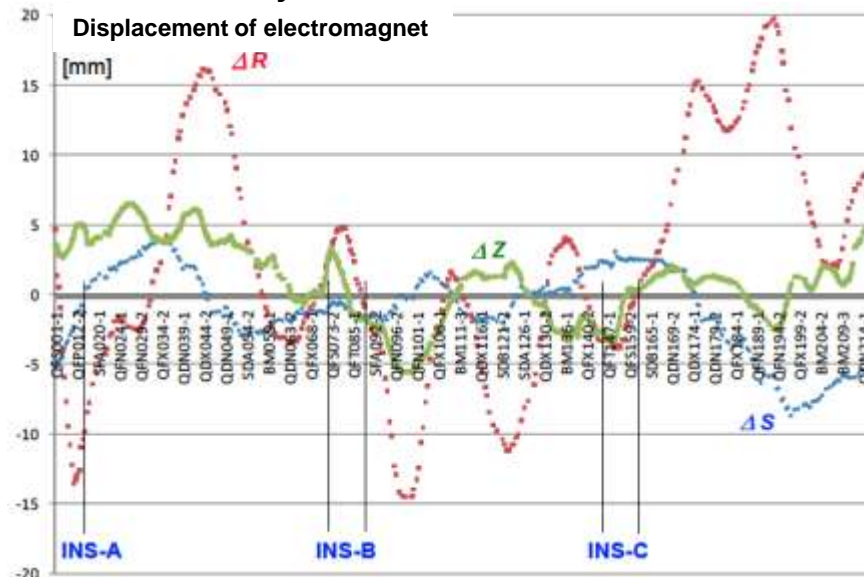
Preliminary Results of Circumference Measurement by Laser Tracker

- It appeared there was a large misalignment in both horizontal and vertical directions.
- ~20 electromagnet mounts shifted more than a limit of simple adjustment.
- All magnets will be realigned by three teams from August to October.

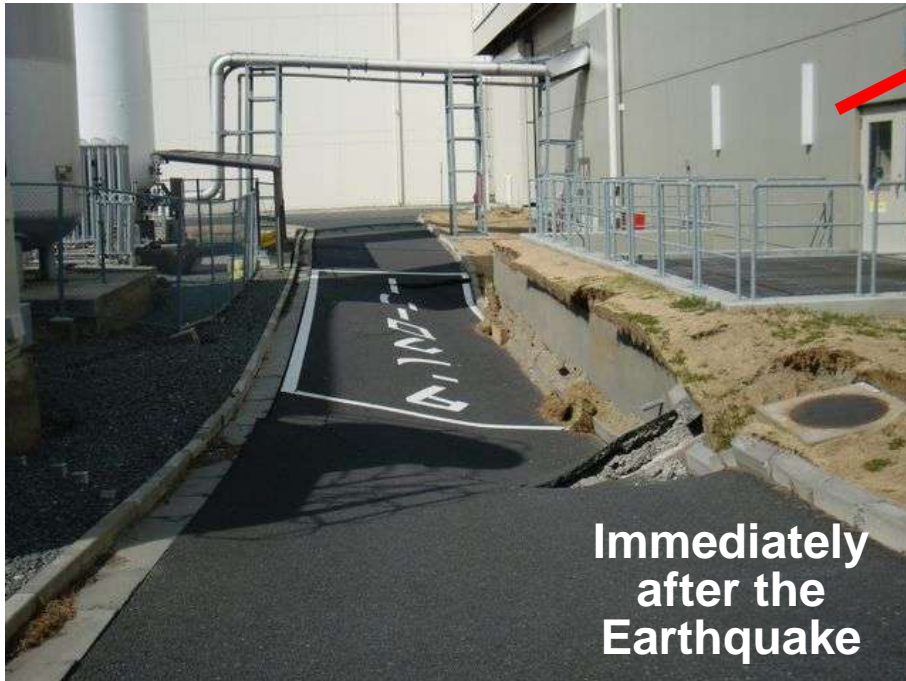
Immediately
after the
Earthquake

Road at the west side of the MLF
building fell in ~1.5 m.

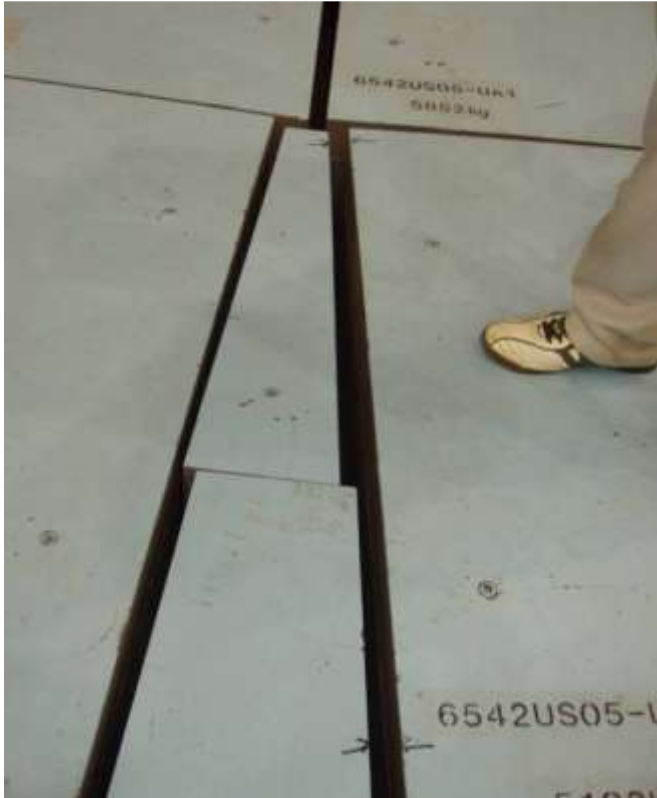
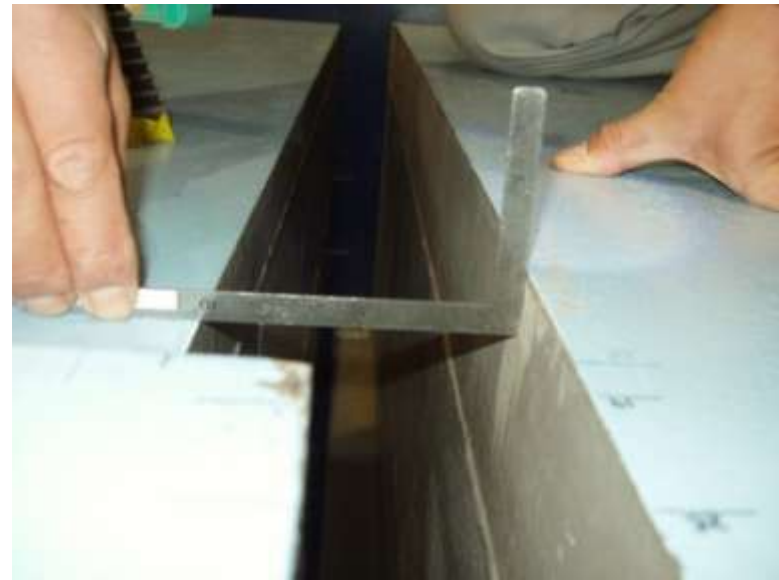
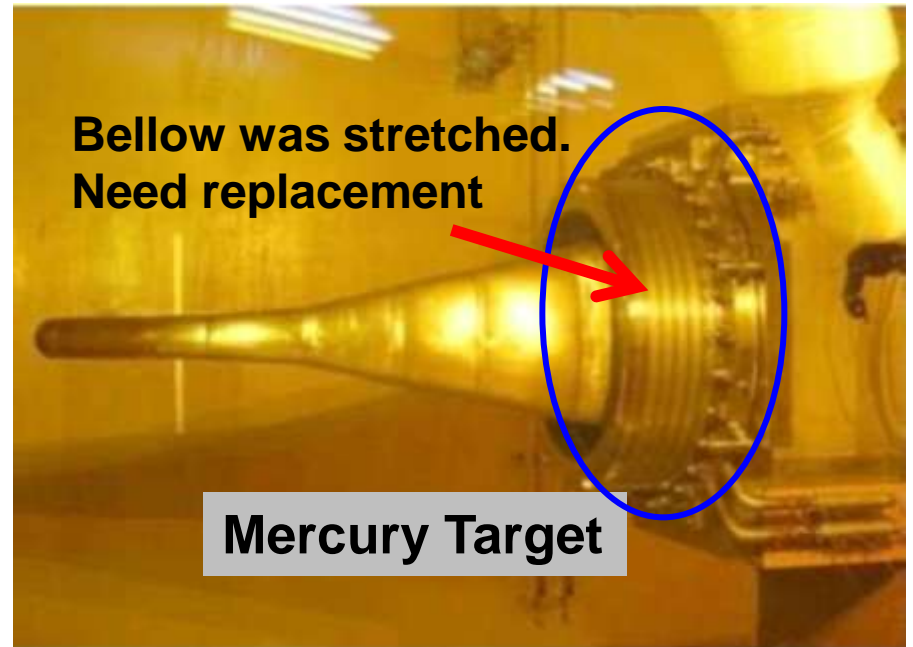
Shielding Walls for Neutron & Target

Bellow of the target shifted ~30 cm.
Replacement is planned.

Displacement of shielding walls in MLF
1st Hall: BL04 Area (left)
2nd Hall: BL20 Area (right top)

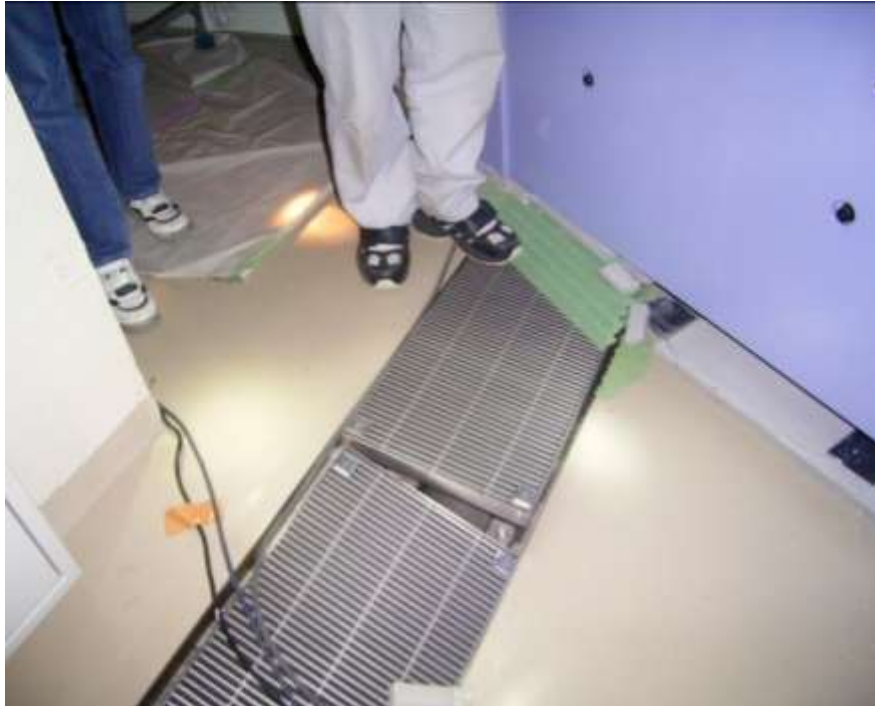
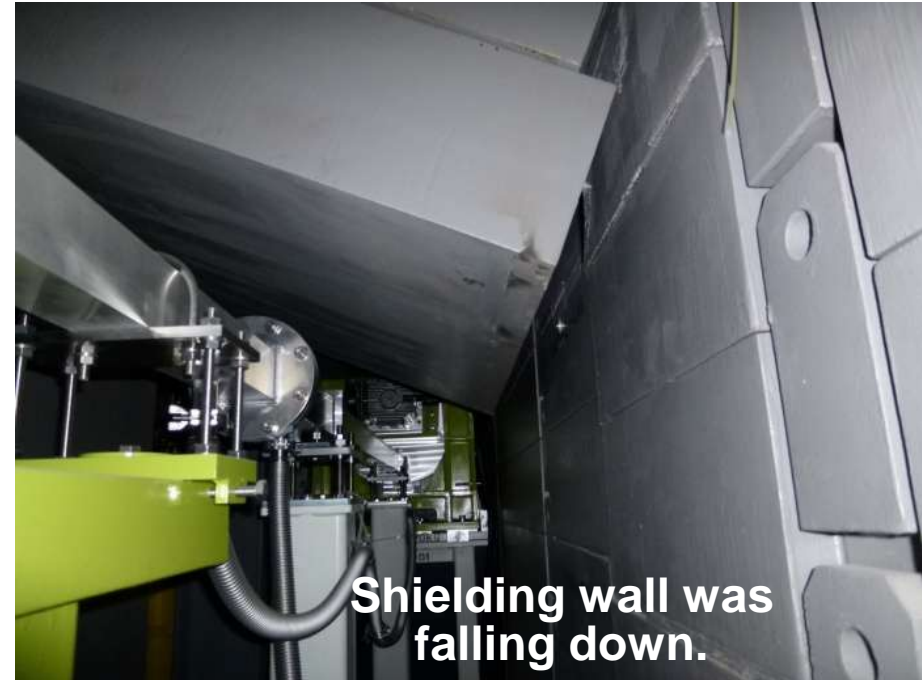
MLF West-side Added Building

A 30 cm gap between the MFL and the west-side added building (left)
BL18, BL19 and BL20 were damaged.

Dropped shield (right)

The repair has been already completed.

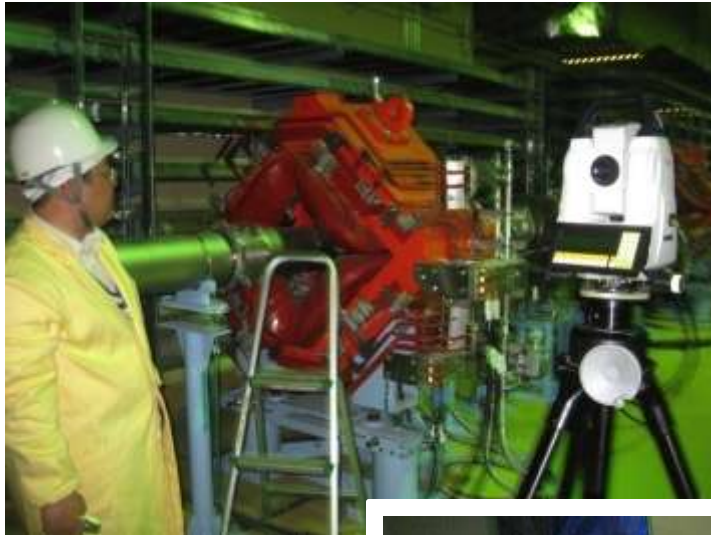
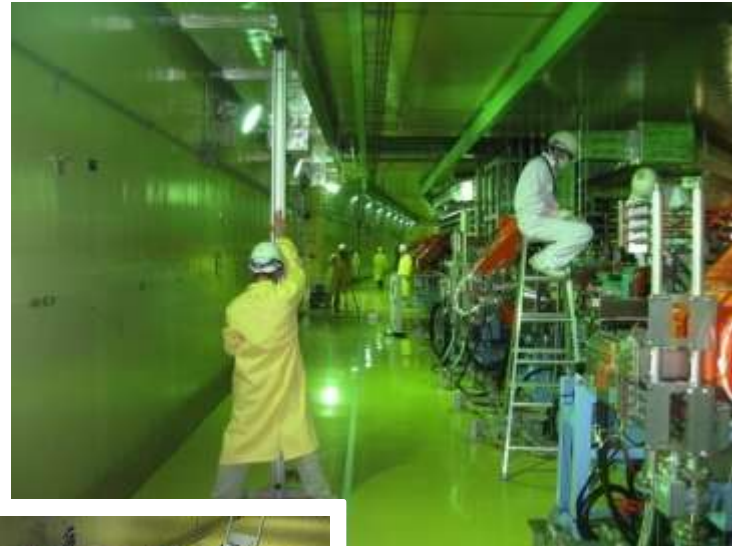
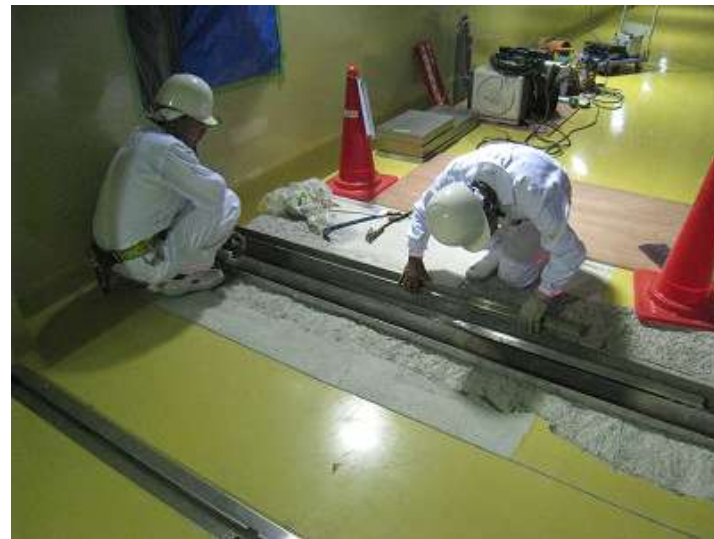
MLF sagged, being 12 mm lower compared to RCS (3 GeV synchrotron).

Mending cracks of walls and floors by injection of plastics

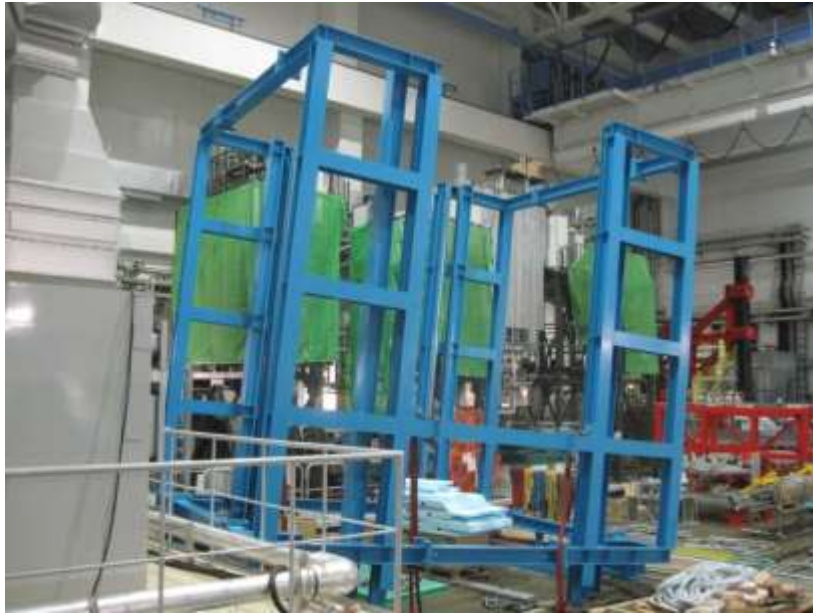
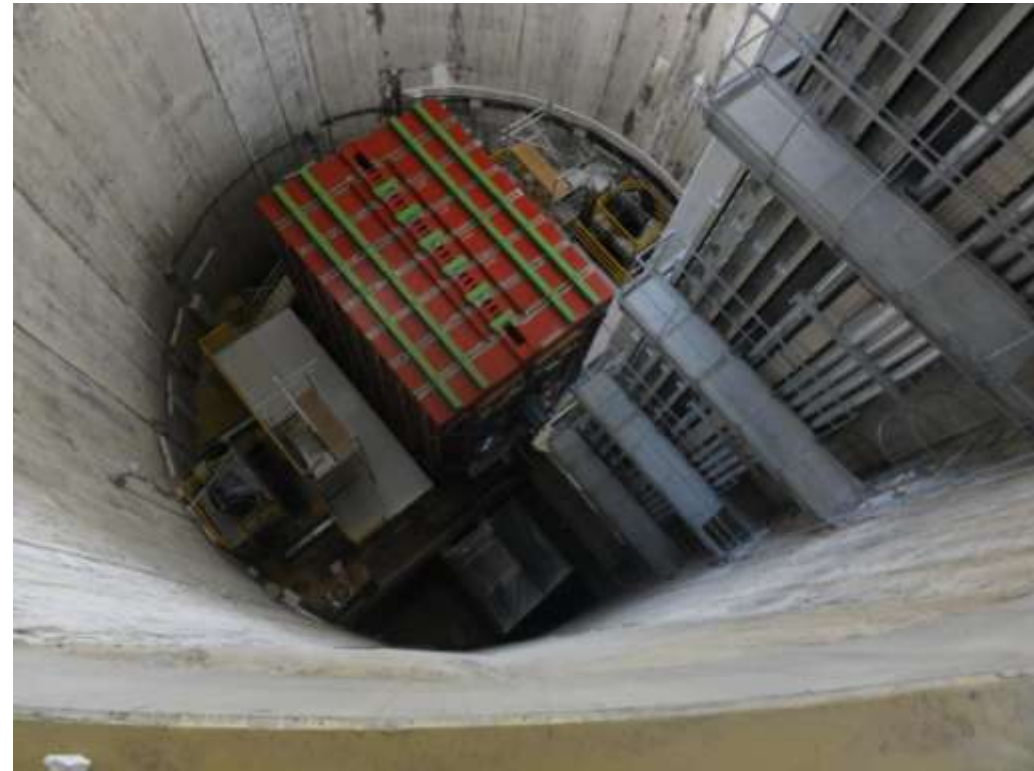
Guiderail for the Horn and On Site Detector

Remote maintenance guide cell for Neutrino Horn
Very dangerous situation, but it was repaired (below).

No significant damages through outside inspection. About 1 cm deep water at the bottom. This problem has been already solved.

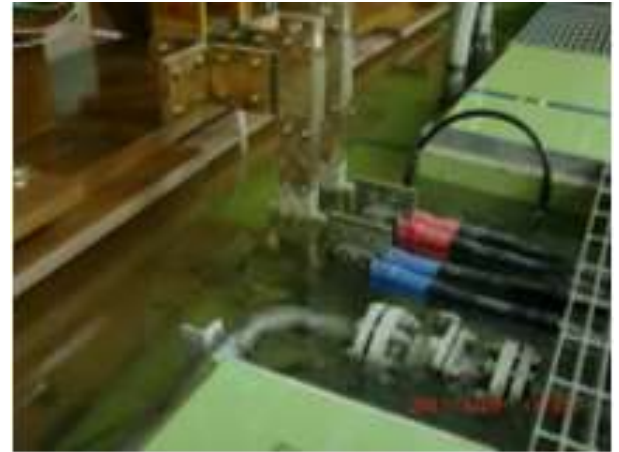
Submerged cables and connectors
