The Radioactive Material Leak Accident at the Hadron Experimental Facility of J-PARC

June 21, 2013

First External Expert Panel

J-PARC Center
Naohito Saito

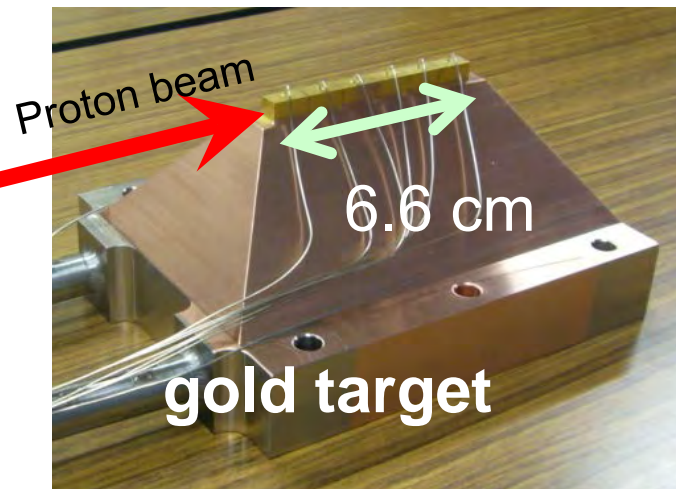
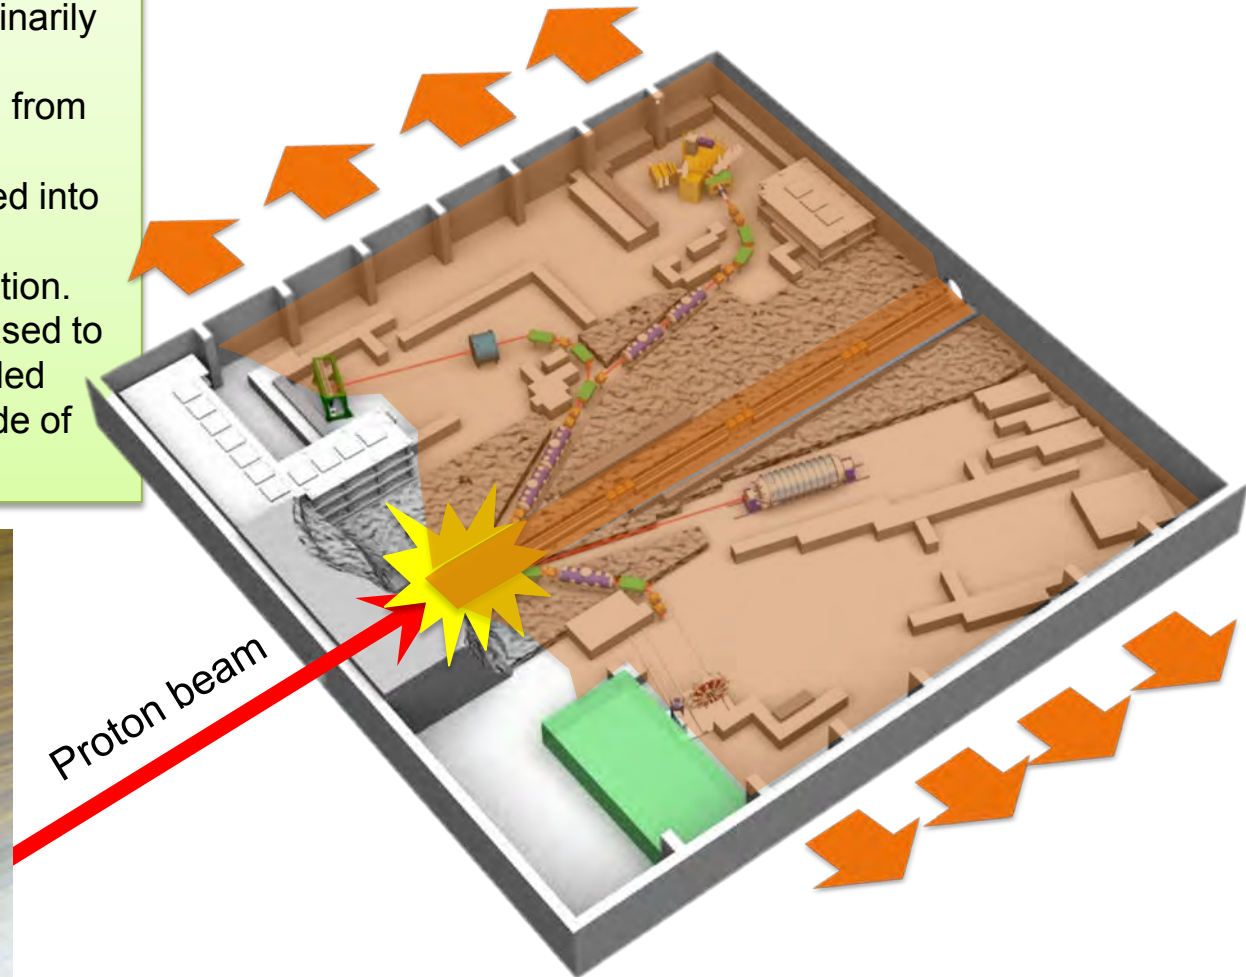
Outline of the Accident

- An abnormal proton beam was injected to the gold target.
- The target heated up to an extraordinarily high temperature.
- Radioactive material was released from the target.
- The radioactive material was leaked into the HD hall.
- Workers were exposed to radiation.
- The radioactive material was released to the outside of the radiation controlled area and to the environment outside of the HD hall.

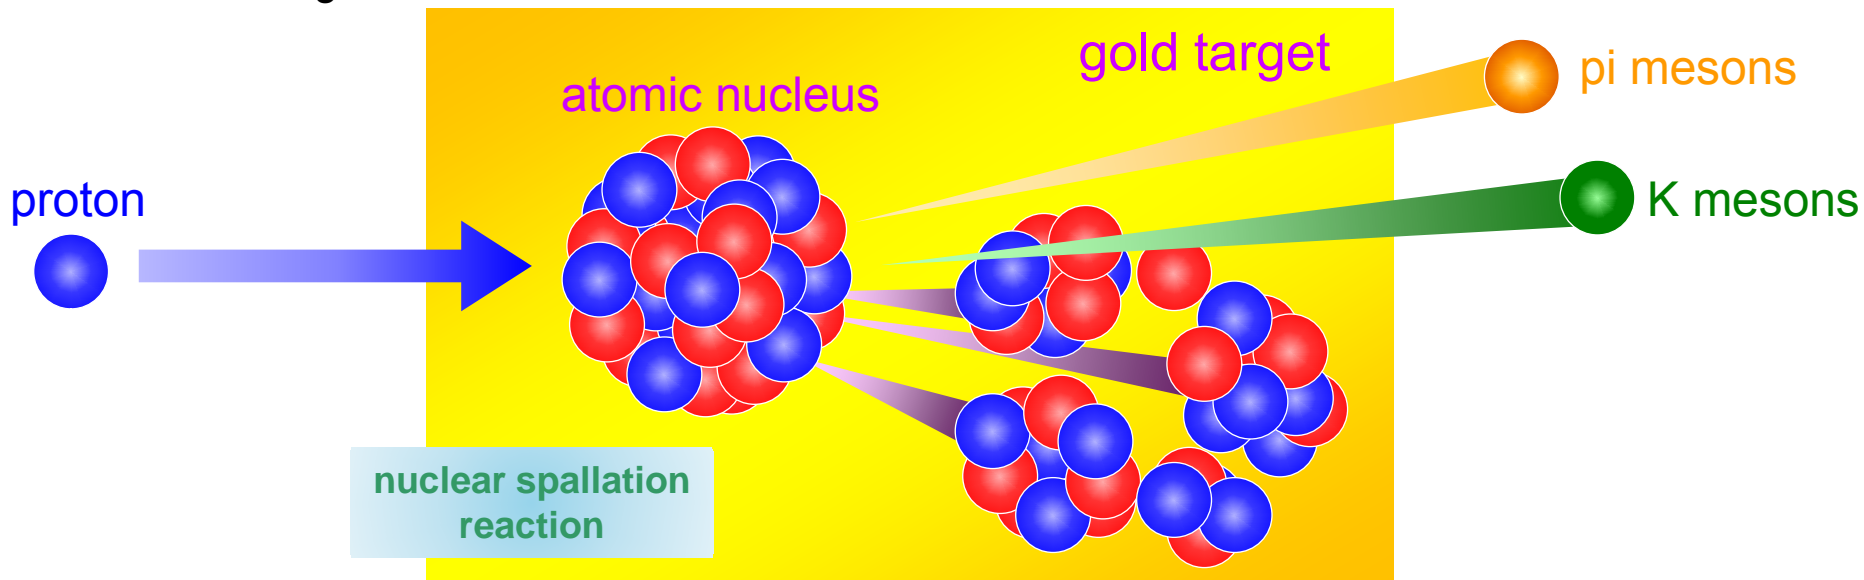
Purpose of the Gold Target

- The target, when bombarded by high-energy protons, produces secondary particles (mesons), which then will be used for research
 - Radioactive material is produced by nuclear spallation reactions.
 - In normal operation the radioactive material stays in the gold target.
 - When the proton beam operation is stopped, nuclear spallation reactions stop and no new radioactive material is produced. Radioactive material decays within the target.

Gold, unlike uranium, is not a radioactive material.

- No nuclear chain reaction occurs.
- However radiations come out from radioactive material produced in nuclear spallation reactions induced by the proton beam in the gold target.

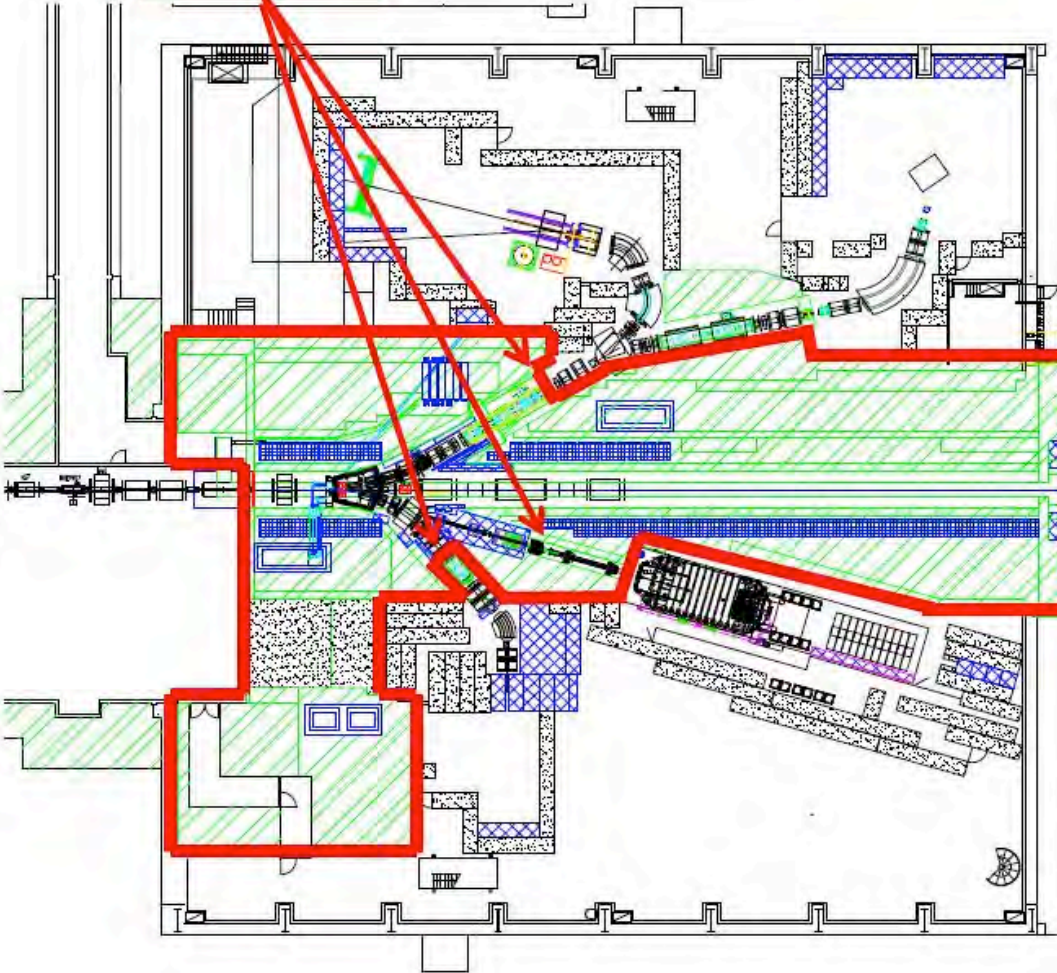
Apertural areas for secondary beam transport lines

Hadron Experimental Hall
