# Report from the Working Group

Working Group for the External Expert Panel on the Radioactive Material Leak Accident at the Hadron Experimental Facility of J-PARC

## Planning of safety measures (Countermeasures against recurrence of similar accidents)

The 3<sup>rd</sup> External Expert Panel Meeting to Review the Radioactive Material Leak Accident at the Hadron Experimental Facility of J-PARC at KKR Hotel Tokyo on 20 June 2013

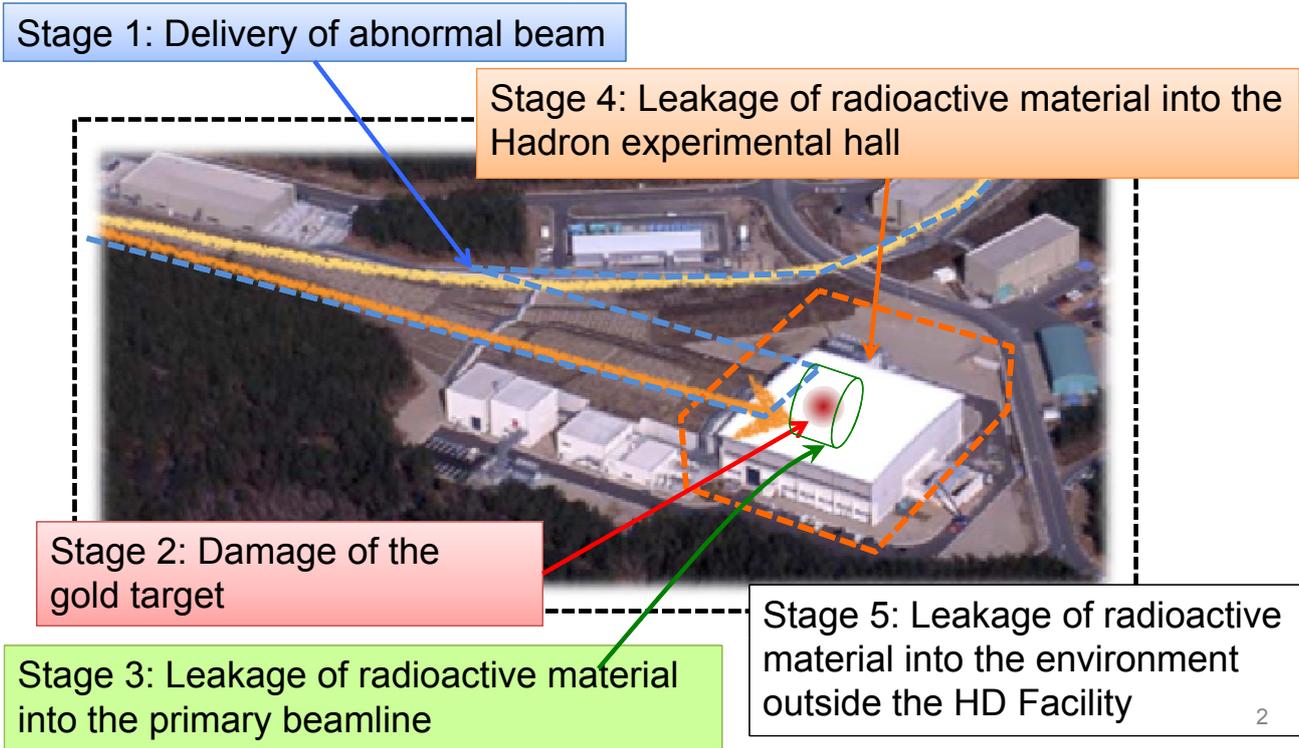
The accident is dissected in five stages for which preventive measures are developed.

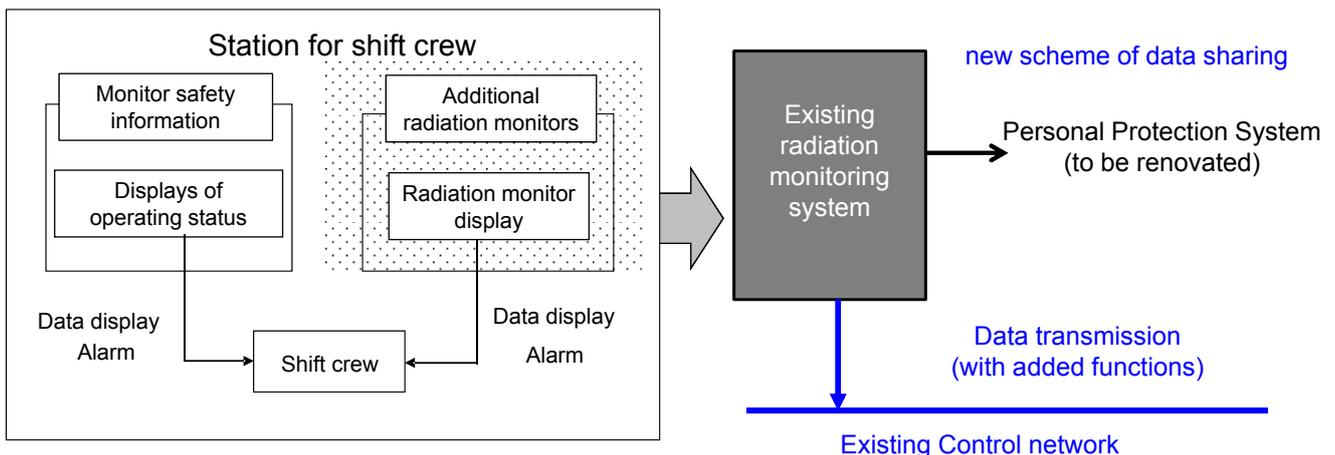
Schematics of the monitor system

Enhanced sharing of monitoring information on the control system network, in close collaboration with each of the facilities at J-PARC

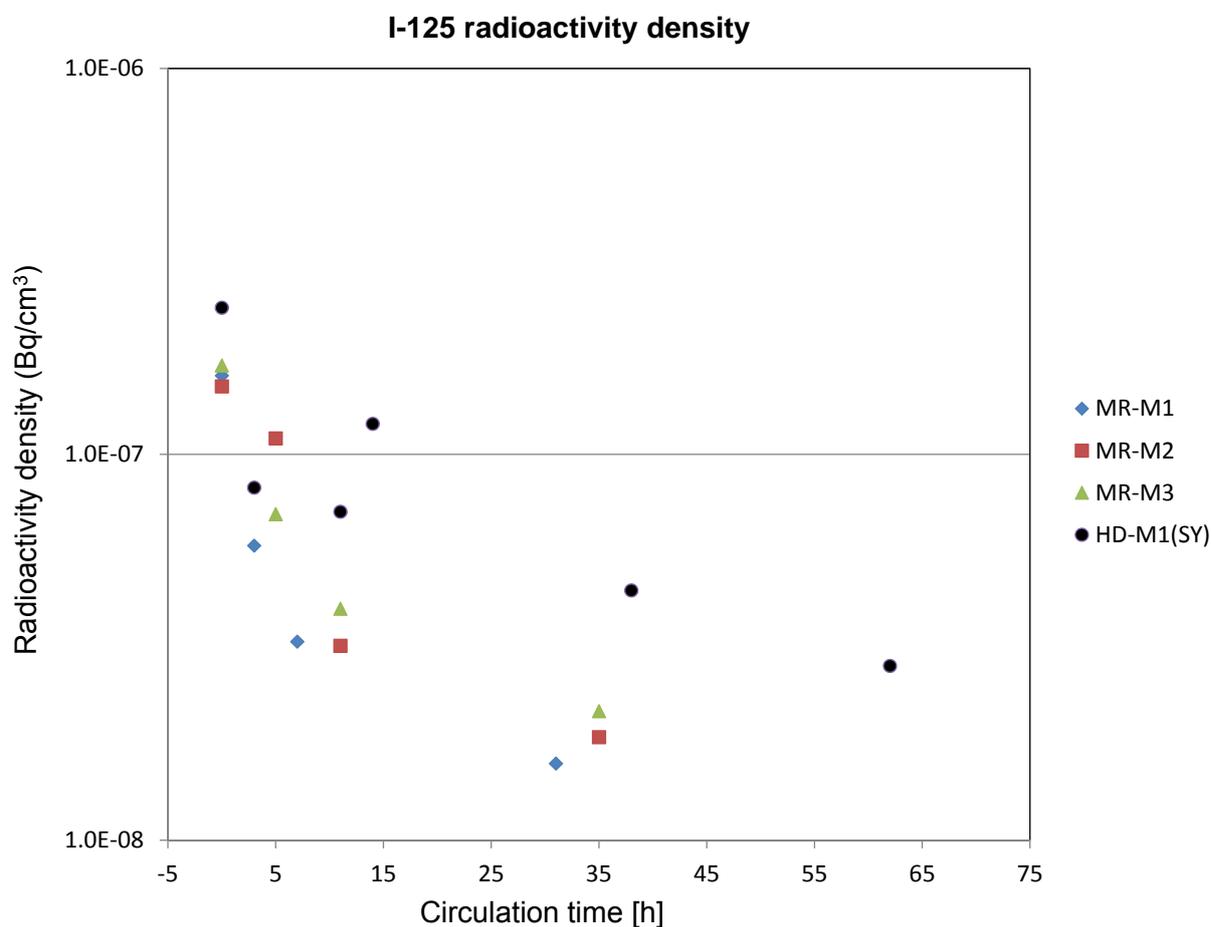
• Charcoal filters have been found to be quite effective

\* The numbers in parentheses indicate the total air circulation times after starting the use of charcoal filters
